PROJECT : MALIAKOS – KLEIDI CONCESSION MOTORWAY

SUBJECT : PAVEMENT ASSESMENT – **VISUAL INSPECTION**

Thessaloniki, January 2004

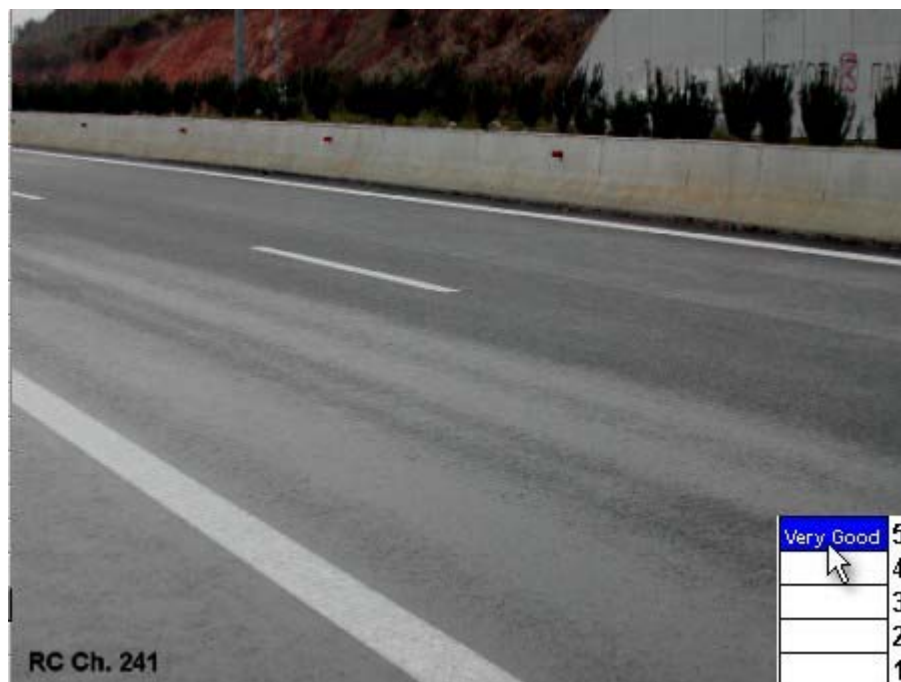
Photo 1 RC Ch.241 (VERY GOOD)

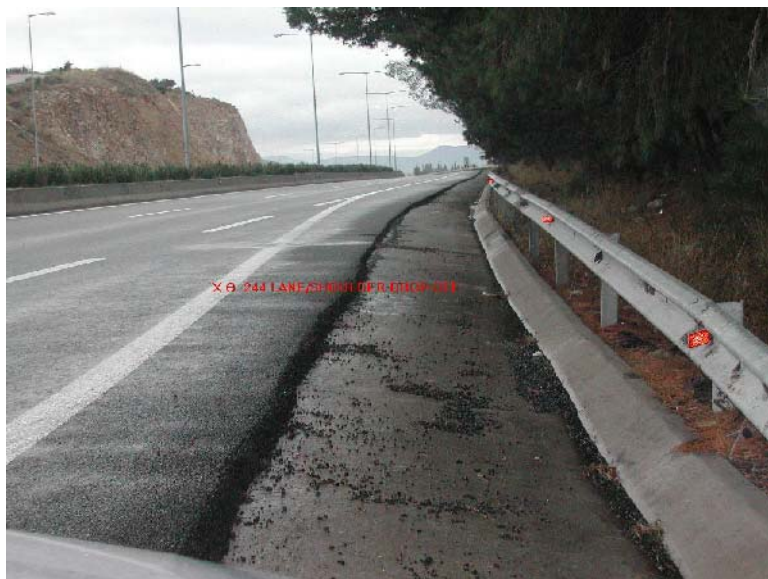
- Lane/shoulder drop off in many places (sometimes more than 10 cm difference in elevation)

Photo 2 RC Ch.241 (Lane/Shoulder Drop-Off)

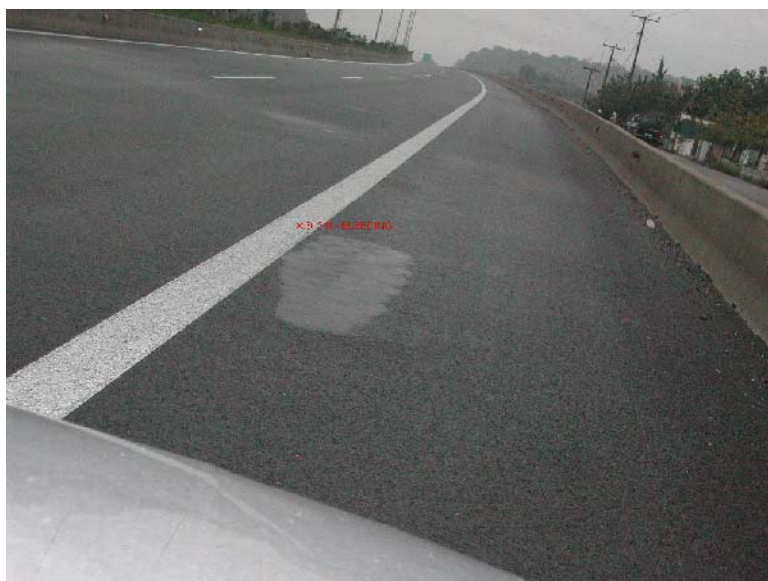
- Rare bleeding on emergency and right hand lane (0.5-4 m²)

Photo 3 RC Ch.241 (Bleeding)
